# INDOOR AIR QUALITY ASSESSMENT

**Lexington Town Hall  
1265 Massachusetts Avenue  
Lexington, Massachusetts**

Prepared by:  
Massachusetts Department of Public Health  
Center for Environmental Health  
Emergency Response/Indoor Air Quality Program  
April 2006

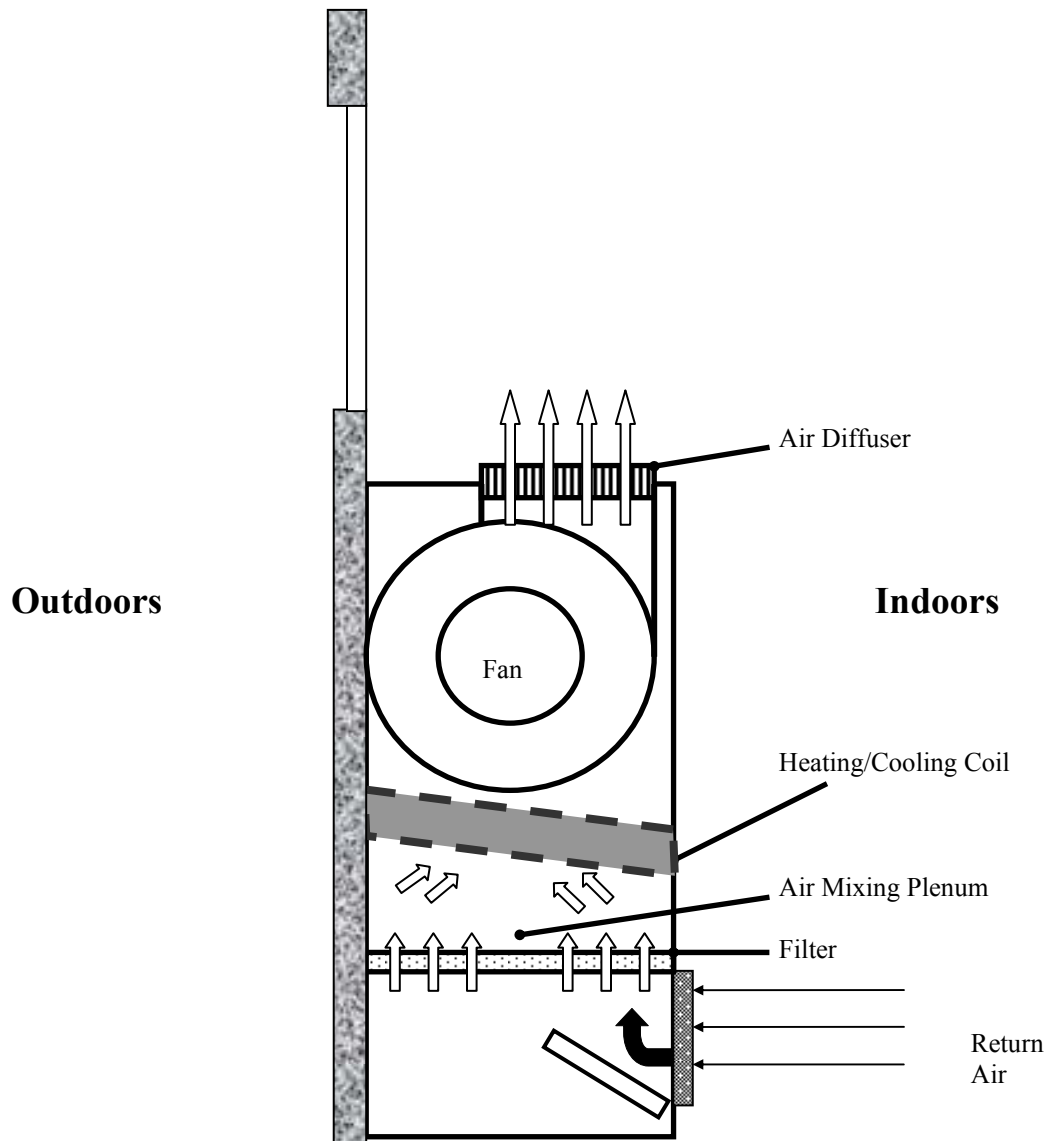
**Figure 1**  
**Fan Coil Unit (FCU)**

Fan coil units (FCUs) located along perimeter walls (Picture 3/[Figure 1](#)) provide supplemental heating or cooling as needed for each room. However, FCUs do not have the capability to introduce outside air; rather they re-circulate air. These units were deactivated in the majority of areas surveyed during the assessment. A number of FCU air

diffusers and/or return vents throughout the building were obstructed by various items, which limits air circulation.

To maximize air exchange, the MDPH recommends that both supply and exhaust ventilation operate continuously during periods of occupancy. In order to have proper ventilation with a mechanical supply and exhaust system, the systems must be balanced to provide an adequate amount of fresh air to the interior of a room while removing stale air from the room. It is recommended that HVAC systems be re-balanced every five years to ensure adequate air systems function (SMACNA, 1994). Town officials reported that the system was balanced approximately a year prior to the MDPH assessment.
